INSTALLING YOUR S/S CD IGNITION SYSTEM

ASSEMBLY PROCEEDURE FOR SPARK PLUG

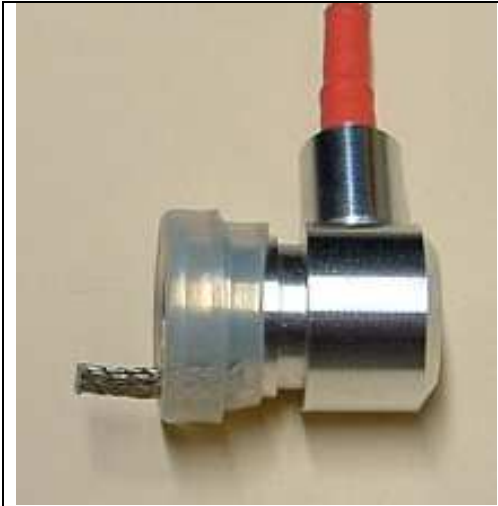
Aluminum cap ready to be installed onto spark plug. It is necessary to roll the silicone tube up onto itself so the cap can be pushed onto the spark plug. You do not have to do this to remove the cap but you do need to rotate the cap back and forth while pulling it off so the spring contact does not pull out of the rubber boot.

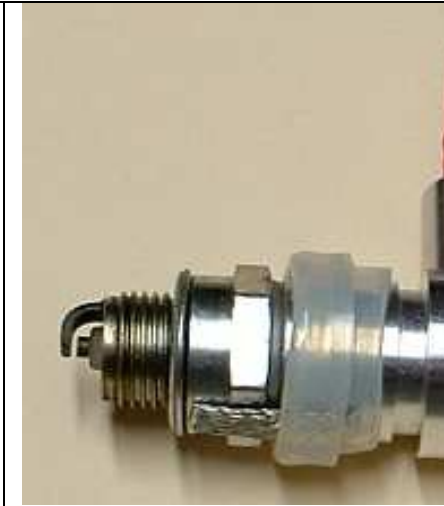
Spark plug properly inserted into cap and rubber boot. None of the insulator is showing between the Al cap and spark plug hex.

We have made every effort to capture all stray electrical noise within the ignition system. The cap is designed for short bantam style spark plugs with a 5/8" or 3/4" hex. When the cap is properly installed on the correct spark plug type there should not be any porcelain visible. The cap will nearly touch the rounded area just above the spark plug hex. If there is any significant amount of porcelain exposed you may experience radio interference. It is most important that the pilot range check their equipment regularly. The difference in radio range with and without the engine running should be very minimal, if not a thorough check of the system should be performed. Battery connectors and switches are a common source of radio interference.

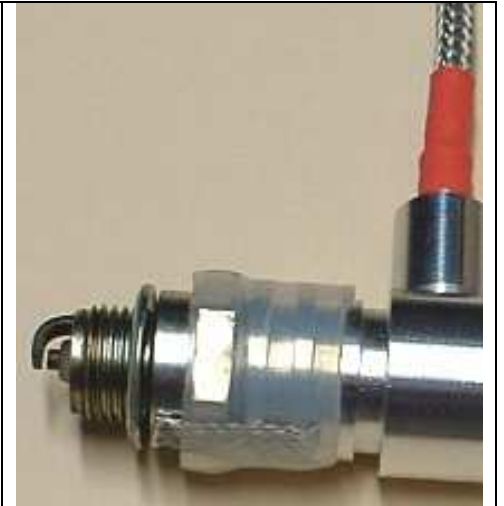
Ground strap and silicone tubing in proper position for engine operation. Notice the silicone tube completely covers the hex on the spark plug.
